Inspection & Maintenance Guide

Keys for Trouble-Free Operation of Wrap System

Keys for Trouble-free Operation of Wrap System

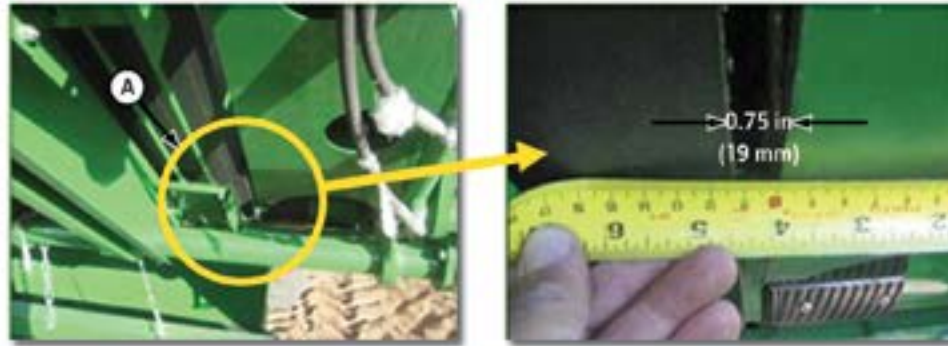
Round Module Builder (RMB) belt position can be inspected from the handler with the machine in harvest configuration and load-wrap mode. The outer RMB belts (A) should be positioned 19 mm (3/4 in) or less from the wall of the RMB to avoid wrap damage and to prevent cotton from carrying around the belts. It is recommended that the rear wrap guides (B) be in the outermost position as shown.

- Excessive gap between outer belts and RMB wall. Adjust gap as described on Page 4 of this guide.
- Damage to baler interior side sheet (2) Stainless steel panel should be smooth and free of dents or bends.

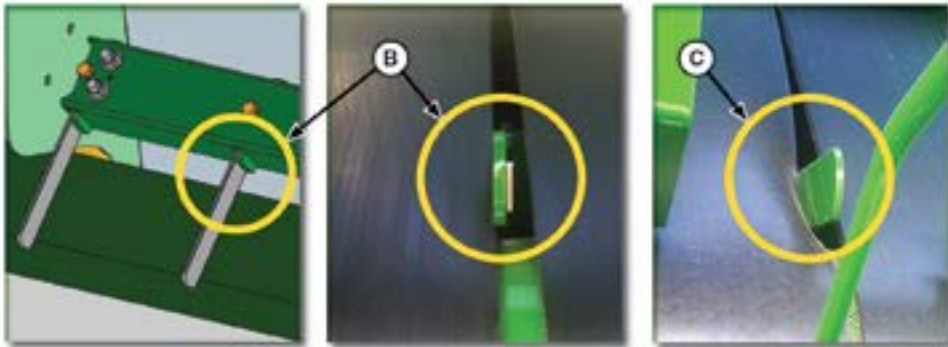
Poor belt tracking occurs when belts ride up on guides and start to curl (C). If not immediately corrected, poor tracking can lead to lace damage, belt stretch, wear, or failure. Refer Section 70, RMB Belt Adjustment in the Operator's Manual for the belt tracking instructions.

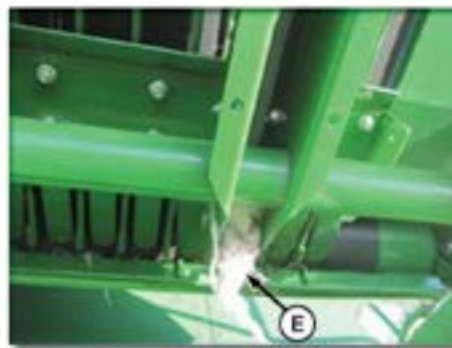
Check 1 - Machine in Transport Configuration:

Clean debris (E) from all of the front pulleys during daily service. Front wrap feed belts should turn freely by hand. Ensure that belts are tight with no slack. Front wrap floor belts can be tensioned via the rear pulley (F).

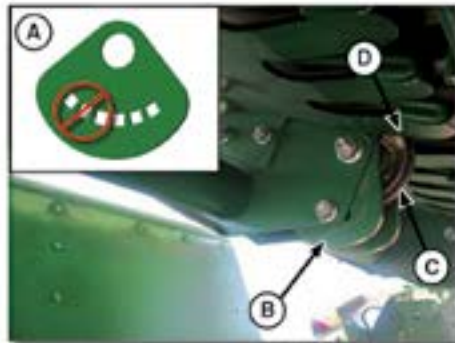
Check 2 - Machine in Harvest Configuration in Wrap Load Mode:

The front wrap feed belts (E) should firmly contact the baler belts near the lower gate roller. When the manual feed button is depressed, visually verify all six front wrap feed belts turn with the RMB belts. If one or more the belts do not engage, wrap feeding issues may occur. To improve belt engagement, adjust the wrap floor cams (B) forward to the next hole position.

- Adjust in service mode with gate in handler, no more than one hole at a time.
- All four wrap floor cams should be adjusted to the same position.
- Do not adjust the cams forward beyond the third hole from the front (A).

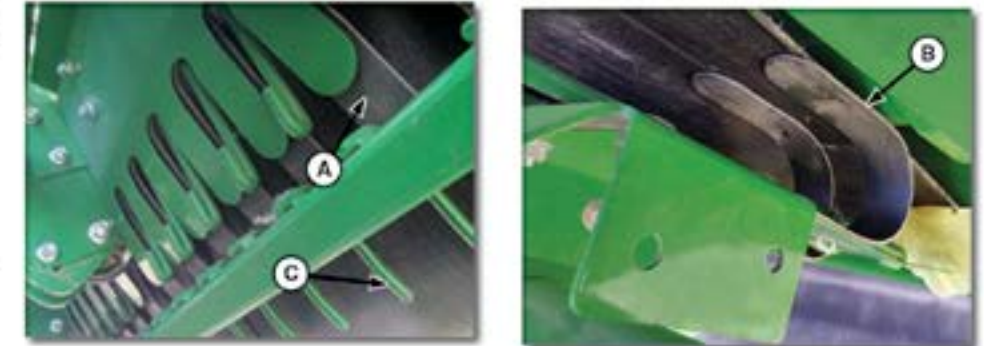
Make sure that plastic fingers are in good condition as shown (A), and not out of position or missing. Plastic fingers need to be straight before machine is stored.

NOTE: It is not unusual for the plastic fingers to get rolled rearward (B) due to reversing motion of baler belts. Typically, the fingers straighten during forward motion of the baler belts. If plastic fingers are curled, remove and flip over. Plastic fingers should only be replaced if broken. The plastic fingers function correctly if there is a gap between the plastic finger and baler belts.

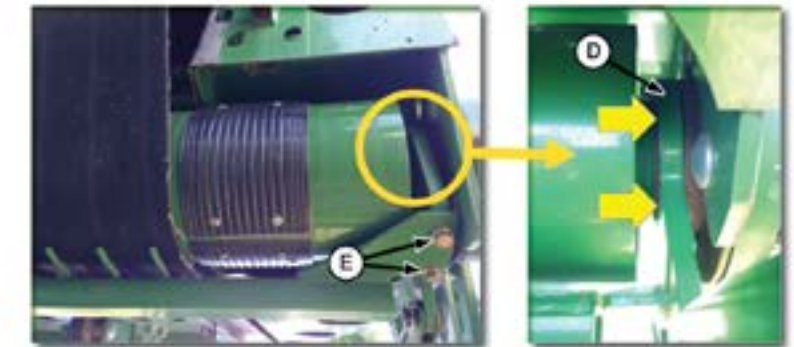
Steel fingers of lower rod guides (C) should not contact the baler belts or laces on the lower gate roll. Maintain 3 mm (1/8 in) to 6 mm (1/4 in) of clearance between the tip of the rods and baler belts. Rods can be manually bent to achieve proper position.

Visually check to make sure the lower rod guide pivot brackets (D) are positioned towards the outside of the machine and rotate on the bearing surface. To reposition, loosen cap screws (E) and move pivot brackets outward.

- Bent finger on the lower rod guide and it is contacting the baler belt. There should be 3 mm (1/8 in) to 6 mm (1/4 in) of clearance between fingers (1) and the baler belts. Easiest to check in service mode with 'gate in handler'.
- **Hint:** Notice that the spacing between the tears is equal to the spacing between the fingers. This can help determine the source of the damage.

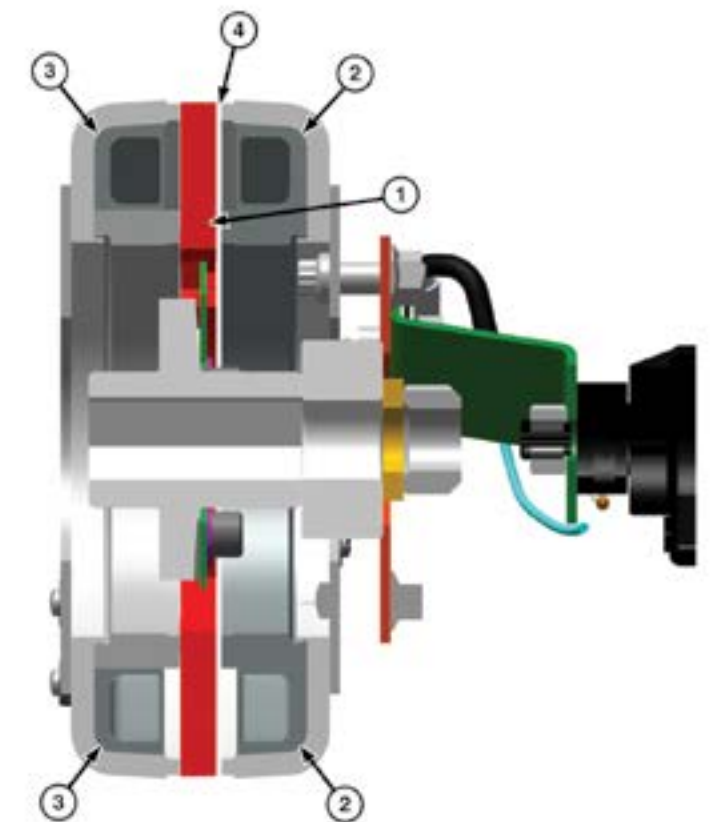
Wrap Clutch Checks:

- The air gap (4) between the armature (1) and the coil (3) should be consistent around the outer perimeter of the clutch.
- In load wrap mode, the bottom rubber feed roll should turn when the advance button is pushed.

4. Proper z-lock separation relies on quick response of the clutch to stop feeding the wrap when the separation label is seen. This is accomplished by the armature plate shifting from the pulley-mounted coil, to the fixed coil. If this does not slide freely, separation is delayed, and some of the next portion may be fed into the chamber. Contact dealer for service.

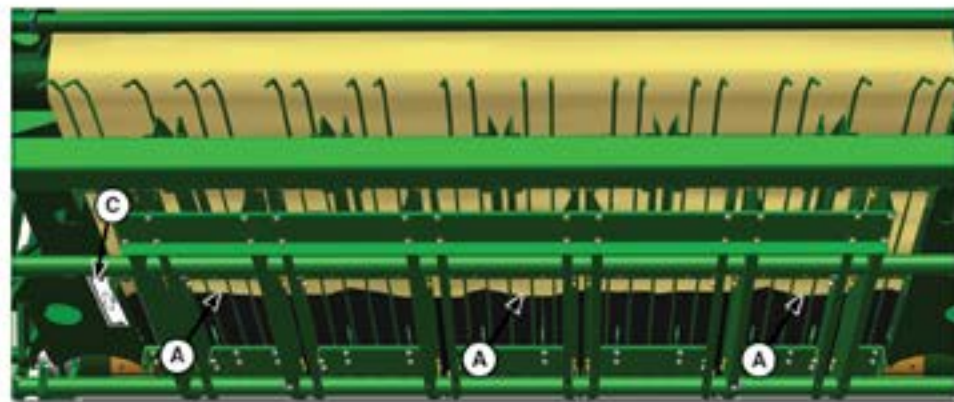
Wrap Leading Edge

After cleaning or transporting machine, ensure that the leading edge (A) of the wrap is properly positioned, and not caught on a rod or pushed up between the belts above wrap floor (as shown at B).

Also ensure that debris has not accumulated on top of the wrap leader during cleaning.

A leading-edge decal (C) is available for installation on earlier machines. Contact your John Deere Dealer for decal N409174.

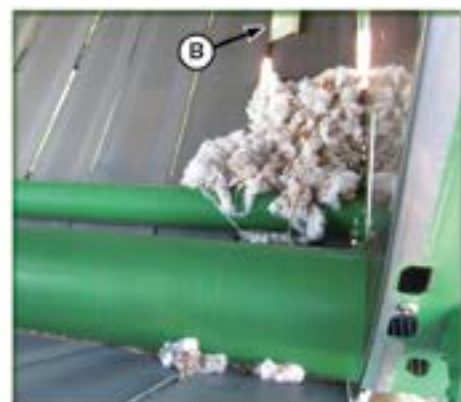
Verify no cotton on top of the belts in the gate chamber (as shown).

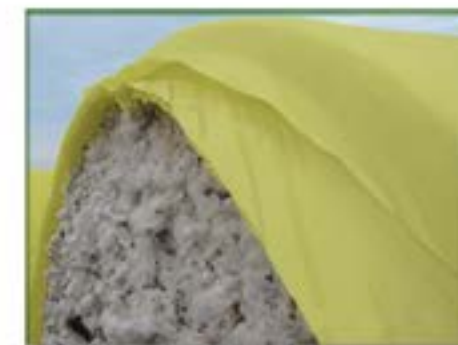
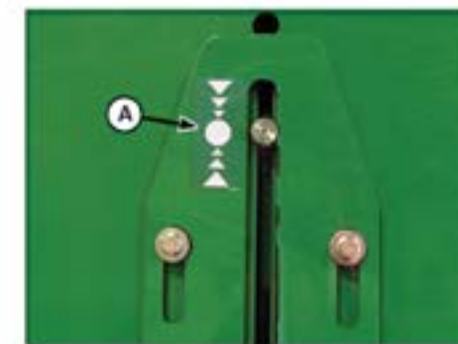
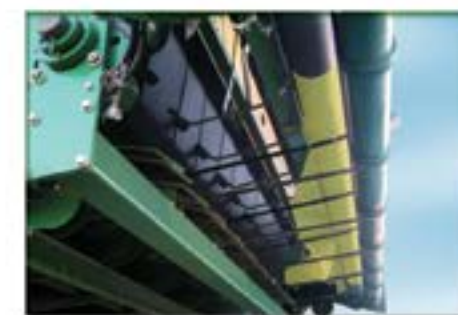
Wrap Troubleshooting Loose Cover-Edge

- Wrap rolls not lowered, resulting in the wrap not being adequately stretched to create the cover-edge.
- Ensure that rolls are down and pin is in the zone indicated by decal (A).
- Inspect wrap roll mechanism. With no roll of wrap in feeding position, lower upper rolls and verify no air gap between upper two rolls and lower roller. If a gap is found, this suggest debris could be in the slots of the wrap box side sheets. Inspect and clean.
- Wrap not being adequately tensioned. Wrap speed should be approximately 233 rpm during feeding, slowing to approximately 100 rpm during separation. This can be monitored on the armrest display in the cab.

If HIGHER speeds than 233 rpm are observed, this suggests:

- Clutch malfunction. Slipping between the armature plate and coil on pulley.
- Belt drive between the RMB and wrap clutch slipping. Tighten belt.

NOTE: Decal shown is on MY12 and later machines. This is available for installation on earlier machines. Contact your John Deere dealer for decal N406903.

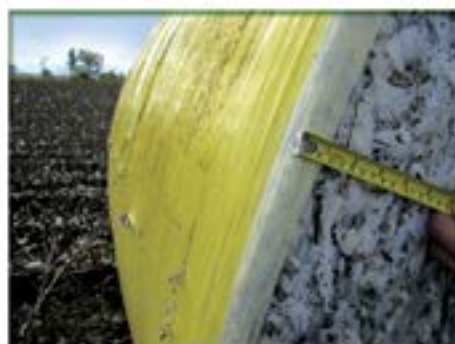
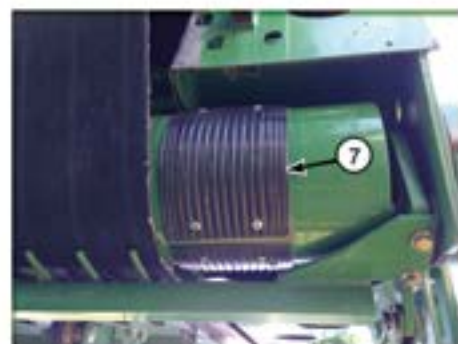
Inadequate or No Cover-Edge

- Cotton buildup (8) inside the baler belts behind the lower gate roll (9). Often this is the result of excessive gap between the side wall and outer belt. Refer to page 4 for inspection and adjustment.
- Debris in wrap feeding area. Verify wrap floor and fingers are clean.
- Improper gate position. Verify that turnbuckles at the top of the baler are set correctly and that the lock nuts are tight.
- Wear of plastic guides (7) on lower gate roller (9). Replace guides if worn.

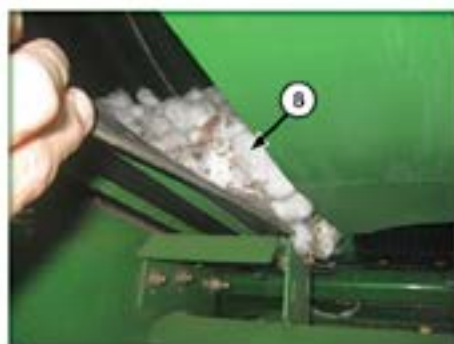
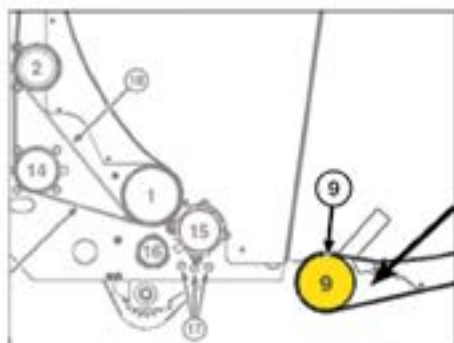
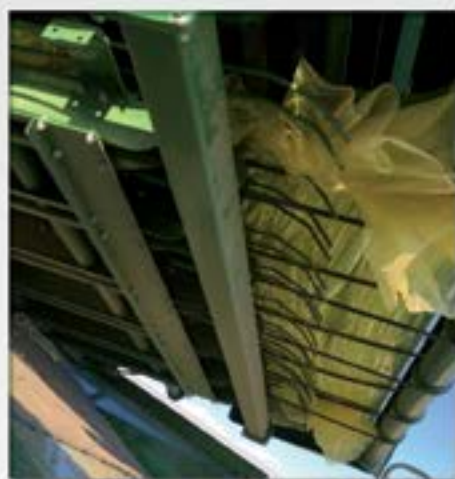
Wrap Bunching on Floor

Machines equipped with grooved lower roller and fingers.

- Leading edge of wrap did not feed into the chamber, resulting in accumulation on wrap floor.
- Check for obstruction at lower gate roll.
- Verify wrap feeding area components (plastic fingers and guide rods) are set correctly. See page 5.
- Verify front wrap floor belts are adjusted correctly. See Page 4.

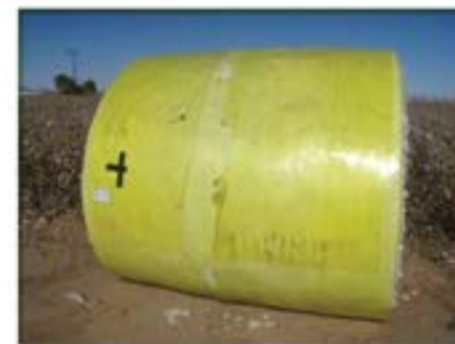
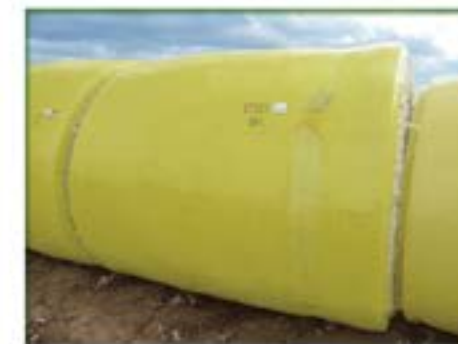
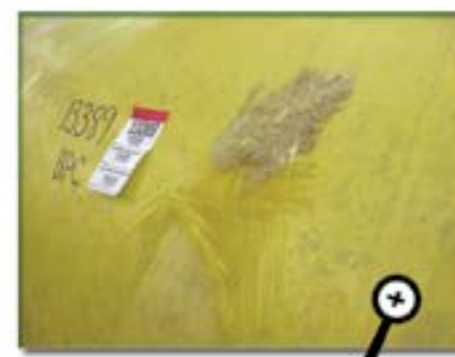
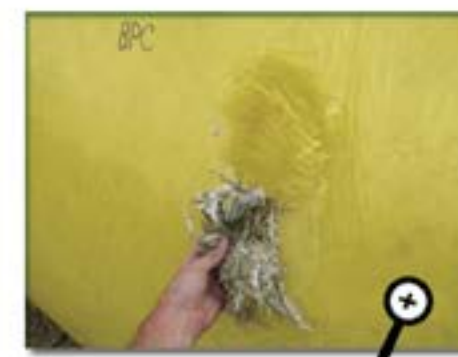
Wrap Torn Dramatically

- Can indicate a damaged or twisted belt in the baler. Inspect bale chamber.
- The photos to the right show the result of a wad of cotton getting lodged in the lower rod guide during wrap feeding, and eventually feeding in with the wrap. This 'wad' of cotton likely ended up on the wrap floor after cleaning the machine. A good practice after cleaning the machine is to verify that the wrap floor, and the leader of the next portion are free of debris.

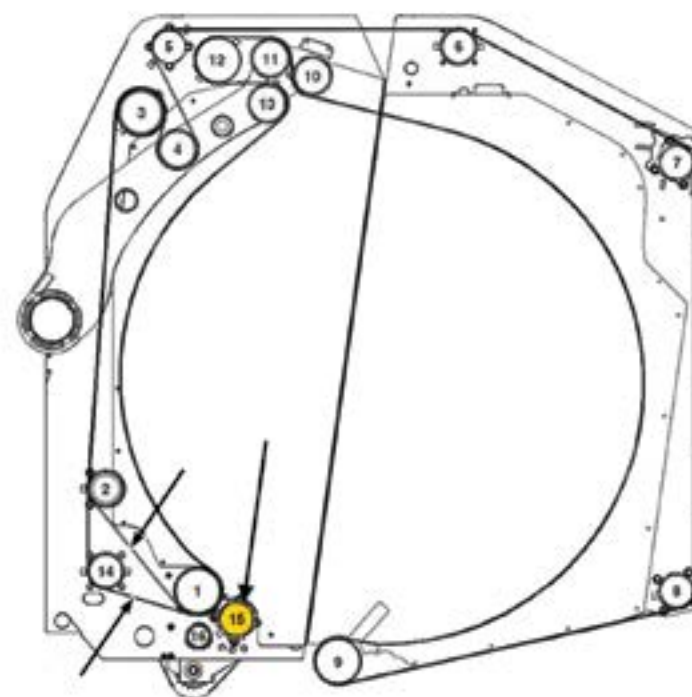
Unwrapped Module Ejected -Wrapping of the Starter Roll

- Wrap feeds into the chamber, but wraps on the starter roll (#15 roll shown below marked in yellow) and winds up on it instead of wrapping around the module three revolutions.

- Bunching of the wrap or uneven feeding increases the chances of this happening. Inspect the wrap floor per Pages 4-5 of this guide.

NOTE: A good practice is to do a quick visual check of the wrap slot via the remote camera before ejecting the module. If wrap is not observed in the wrap slot after feeding wrap is complete, this indicates that the wrap has gone on the starter roll.

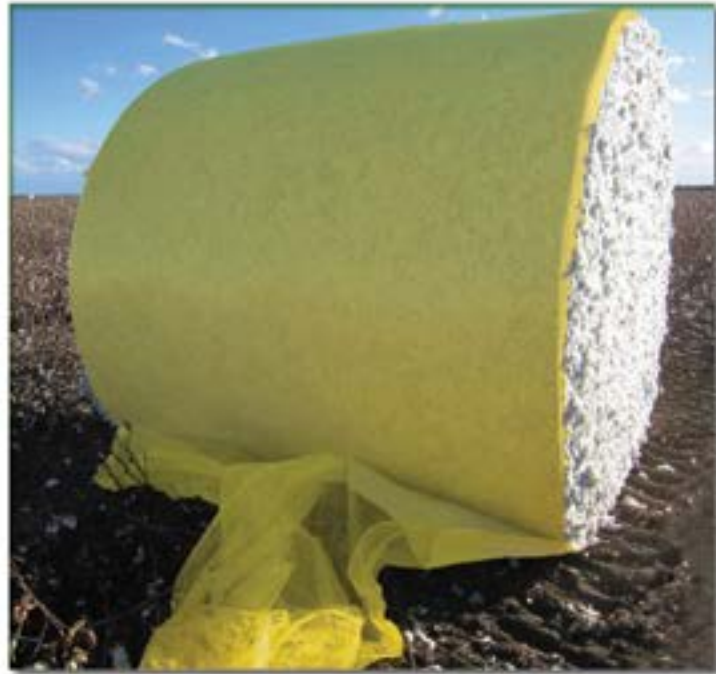
Partially Wrapped Module or Wrap Trailing Out of Gate After Eject

- Wrap did not separate and pulled in another portion. Upon eject, when the round module rolls down the ramp, it unrolls the wrap that is on the module.

- Most likely cause is the clutch armature is seized and did not stop the wrap feeding when the separation tag passed the IR sensor. Refer to page 5 for information concerning the clutch.

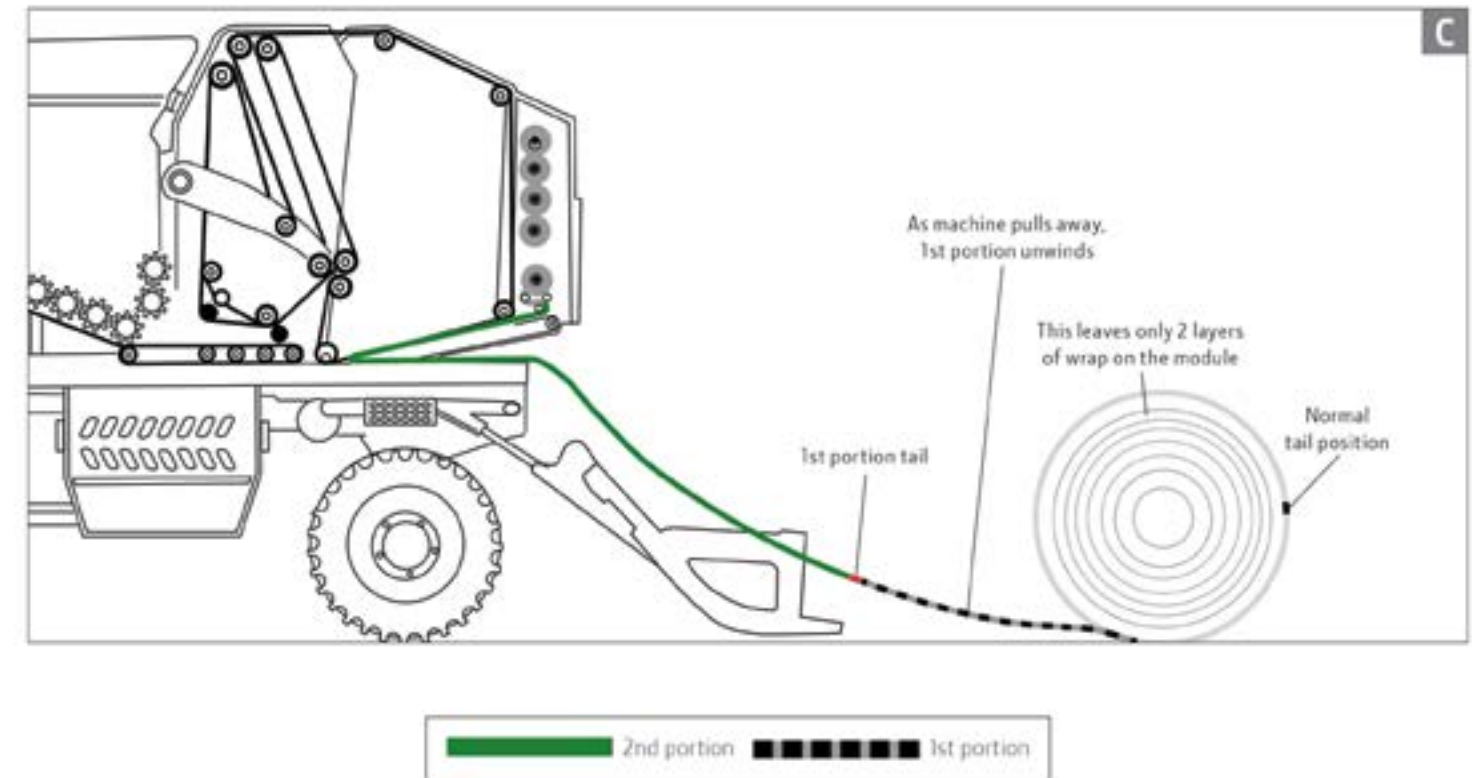
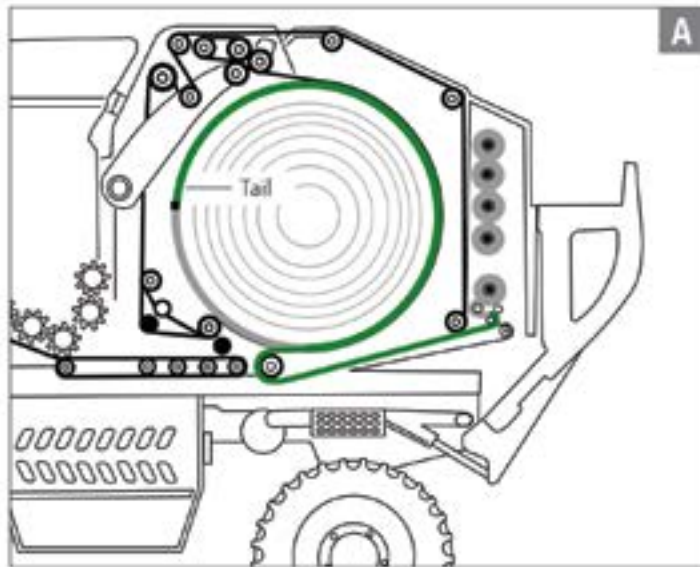
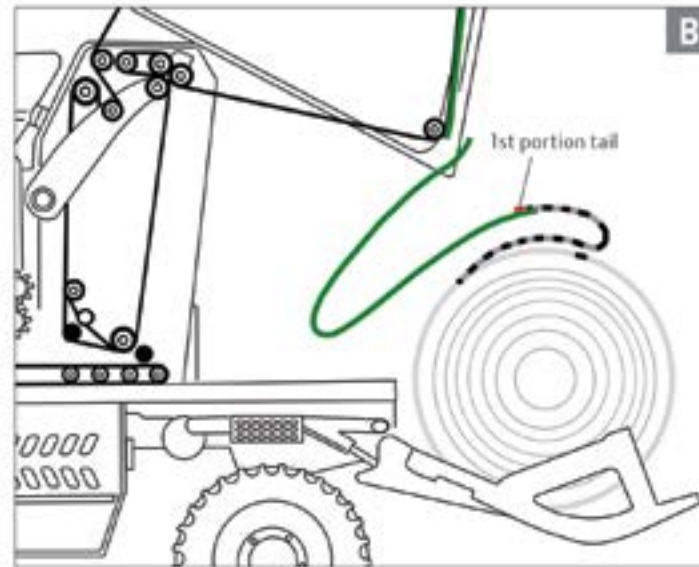
- See Figures A, B & C below to further illustrate: (A) Normal machine sequence after z-lock separation is to rotate the module in the chamber in order to get correct tail orientation after the module is ejected. This means that the tail is towards the frontside of the module (nearest the cab) before eject. If z-lock separation does not occur, this means that the baler will pull in approximately 5 m (15 ft) of the next portion. (B)-(C) At eject, the module rotates approximately 180 degrees from when it is in the chamber to being on the ground. As the module rolls down the ramp and handler, it unwinds this 5 m (15 ft), as well as continues to unwind the tacky of the first portion.

Potential risk: Loose tails can cause contamination of material.

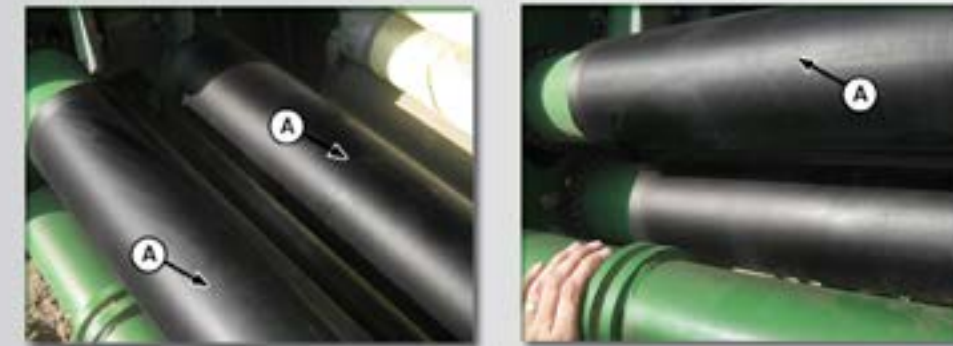
Adhesive Deposit on the Rubber Rollers

- Possible adhesive from the separation label or RFID label (A).
- Adhesive from the tail.

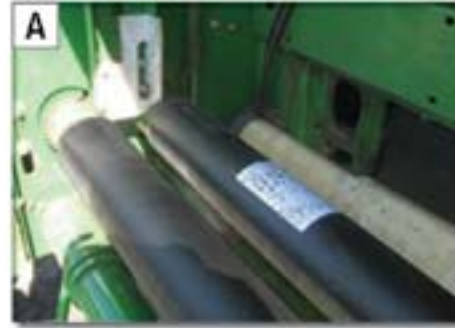
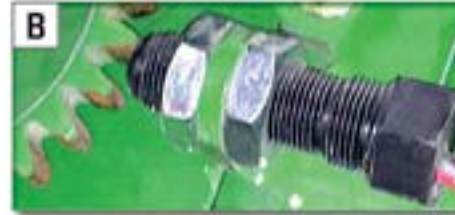
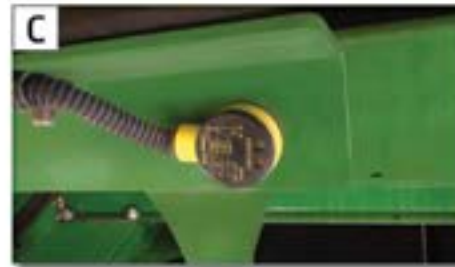
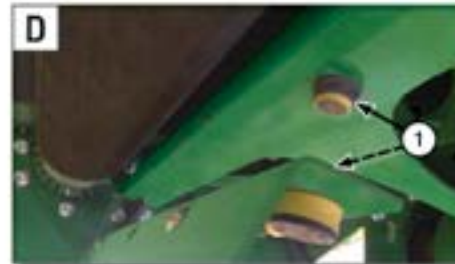
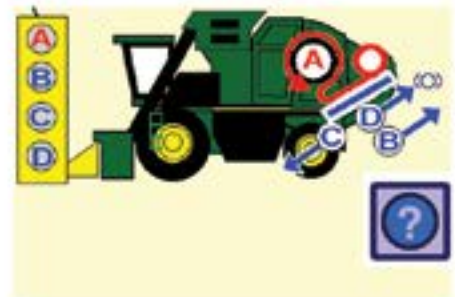
1. Separation label not present, or comes off and adheres to the wrap rolls.
 - If found on roller (Fig. A), remove and clean with acetone utilizing appropriate PPE (Personal Protective Equipment).

- Record serial number of portion and report to your John Deere dealer.
2. Wrap separation sensor (Fig. C & D) malfunction.
 - Sensor can be manually checked by blocking sensor with your hand. A red visual indicator light on sensor body is observed when sensor is blocked.

- Ensure plastic retaining nuts (1) on the sensors are properly tightened.

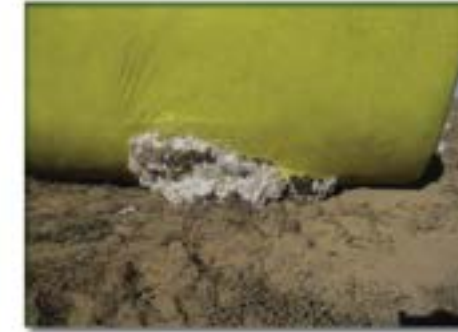
Handling Damage to Wrap

- Turning tractor before forks pulled away from module.

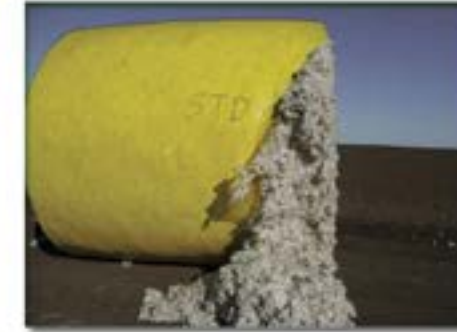
- Turning machine or raising handler before handler is away from module.

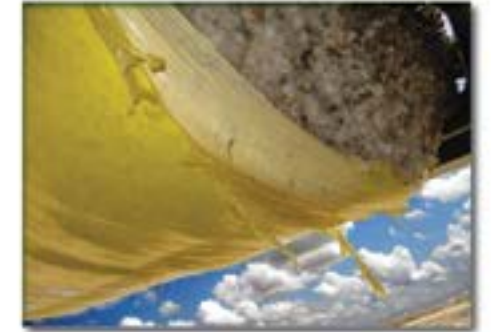
- Bottom drug on the stalks

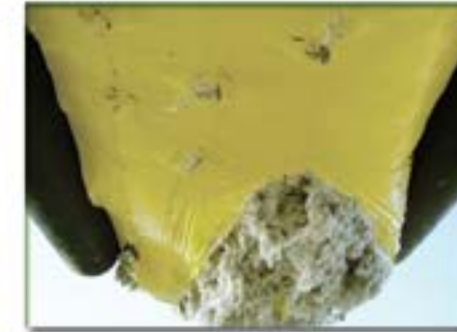
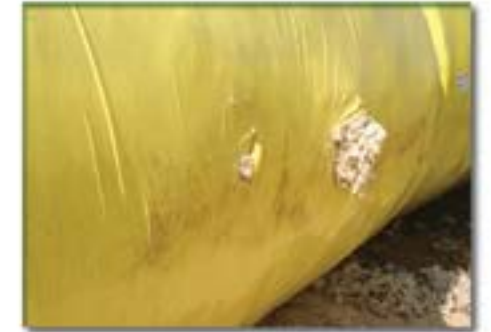
- Damage if inappropriate chains used (see figures below), or if chains are run after load reaches front of truck.

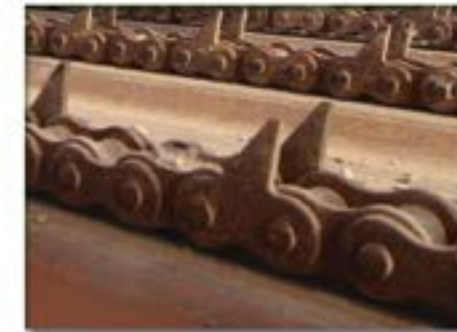
- High potential to damage wrap.

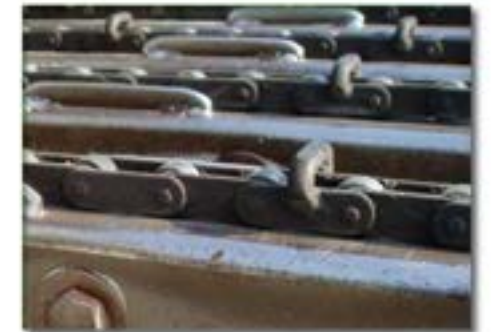
- High potential to damage wrap.

- Typical recommended chain.

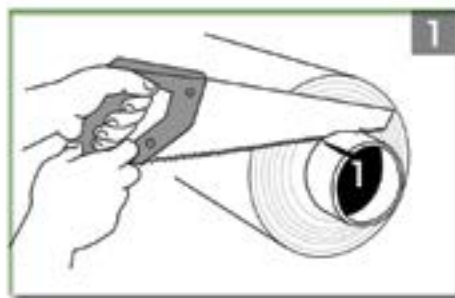
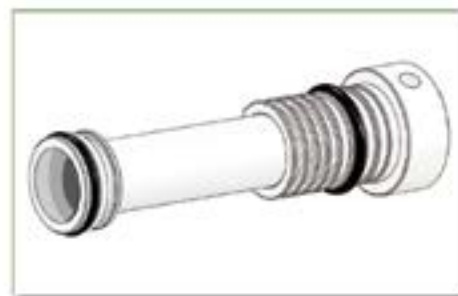
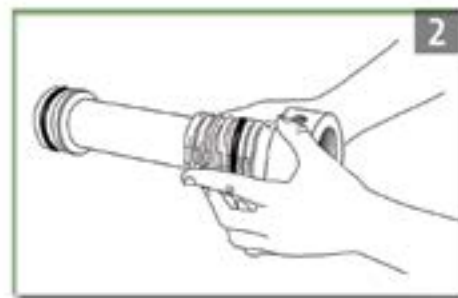
The core repair extension is a tapered plug which can be inserted into the original core of the RMW roll to replace a cracked or damaged core end. The extension has a set of 7-8 grooves that are graduated in diameter, from narrowest to widest. A pair of rubber O-rings is supplied in the kit. Use both the wide black O-ring and the narrow black O-ring as described below.

1. Cut off the damaged end of the core carefully (Fig. 1), making sure not to damage the roll of material. Refer to step 6 for maximum core length.
2. On the repair extension, slide the wide black rubber O-ring onto the sixth groove in the external grooved section. The narrow black O-ring supplied in the kit should be placed on the short grooved section located in the internal side of the flange (Fig. 2).

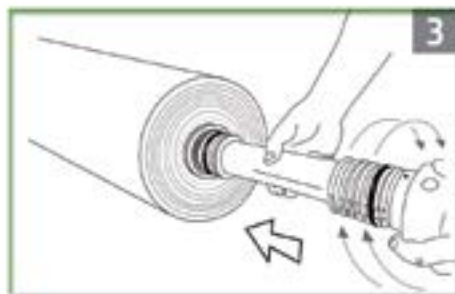
3. Insert the repair extension into the core in spiral motion (Fig. 3). There should be a slight resistance when inserting the extension.

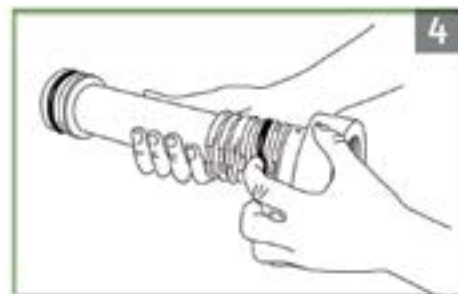
4. If the repair extension is too loose, move the O-ring to a wider groove (Fig. 4) and repeat step 3. Moving the O-ring closer to a wider groove increases the resistance.

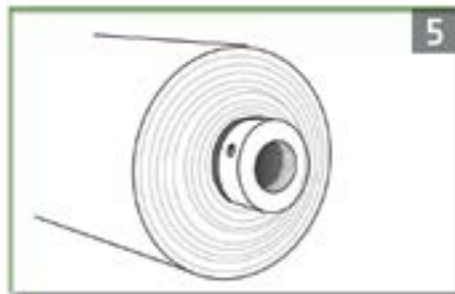
5. The extension should firmly grip the core (Fig. 5).

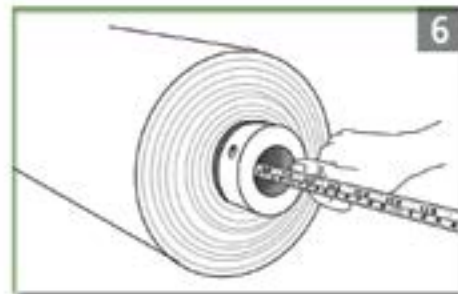
6. With core repair extension inserted, measure the overall length of the core by inserting a tape measure through the inside of the core (Fig. 6). Overall length should meet specification: 2790 – 2784 mm (109.84 in – 109.66 in).

NOTE: Must not exceed maximum length or roll will not install properly.

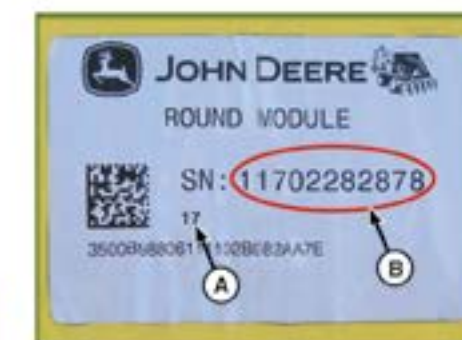
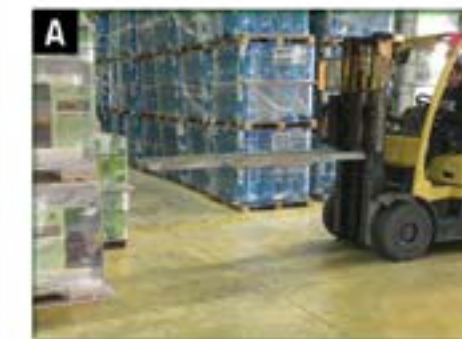
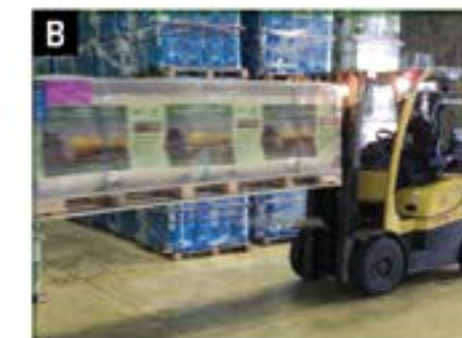
- A. Portion number.
- B. Unique RM Serial Number (circled in red) – First two digits = Year of Manufacture.

When reporting an issue, ensure that both serial and portion numbers are included.

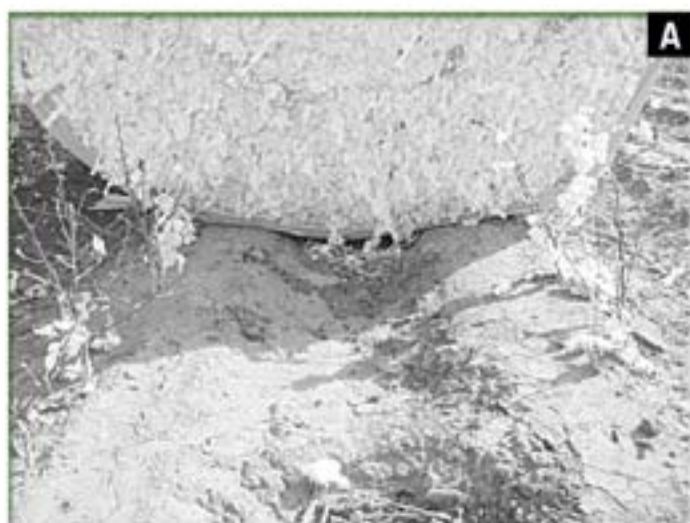
Incorrect Staging Surface

- Modules should be staged on a high flat surface. Staging on well-defined flat driveways or a flat disked surface is optimal.
- When choosing a staging location, ask yourself "Can a module truck retrieve from this location after a significant amount of rain".
- If a module truck tire and/or tracks have to slip to gather the load, damage may occur to the underside of the module due to the relative chain slip.
- If at all possible do not stage modules on top of rows or beds or internal portion of field where module truck access is difficult. Modules take the shape of the surface they are placed on as shown in (Figure A). Setting on beds or uneven surfaces requires digging into the ground with the module truck chain to safely get under the entire surface of the module.

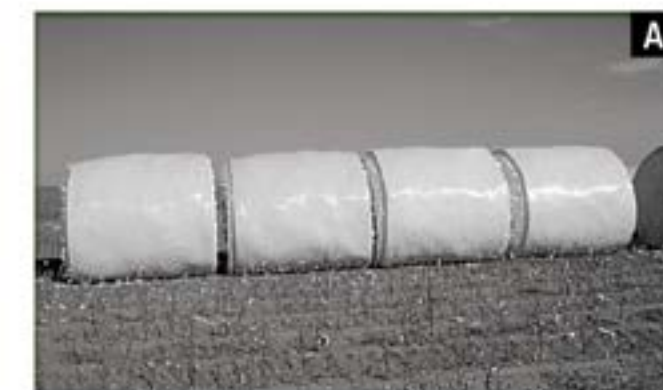
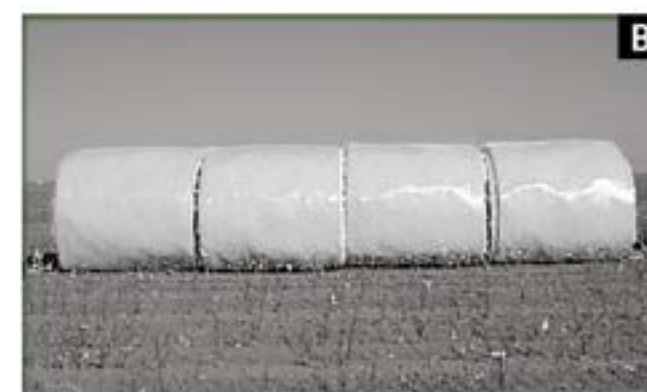
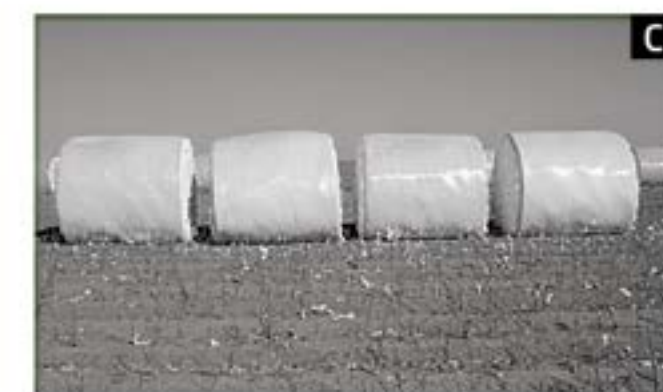
A- Proper Center Alignment B - Improper Center Alignment

Improper alignment increases the chance of wrap tear due to the truck driver having to stop and start loading procedure and from the modules scrubbing the trailer walls.

Too little gap as shown in (Figure B) can cause tearing as modules travel up module truck incline due to interference with adjacent modules. Also, having module ends contacting each other during long-term storage can increase chances of mold growth. Gaps between modules allow ventilation.

Excessive gap as shown in (Figure C) can cause four modules to be too long for the available truck bed lengths.

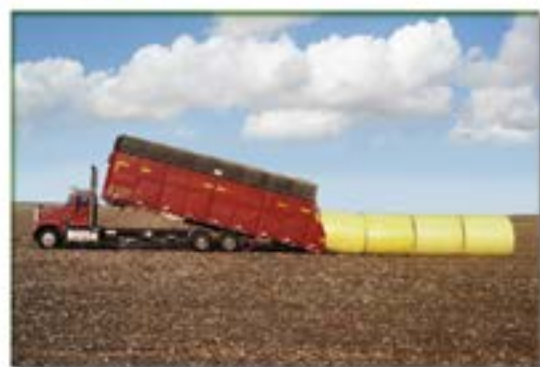
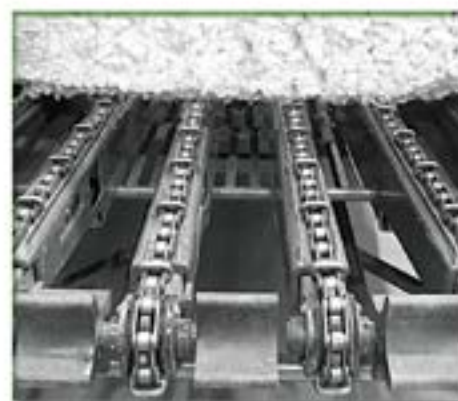
Preferred Chain

- Module trucks with 12 bed chains must have inside eight chains replaced with the Stover RMS chain to prevent damage to the module plastic wrap.
- Module trucks with 11 bed chains must have inside seven chains replaced with the Stover RMS chain to prevent damage to the module plastic wrap.

- As a final check, nonStover RMS chain is only allowed within 43 cm (17 in) of module truck inside wall surfaces.
- If chain tail wheels are the sprocket style, paddle style with sharp points, or narrower than 5 cm (2 in), replace with the wide smooth paddle style tail wheels.

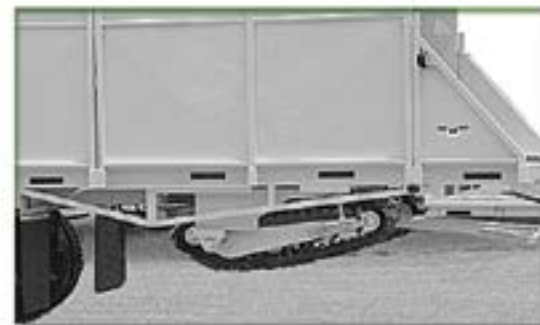
Preferred Module Truck

3. Do not run up front face of the first round module up tight against the front of the truck bed (headboard) for any reason. Stalling the travel of first module causes cutting of the wrap due to relative motion of chains and also close up gap to the next module. If modules are not staged properly, do not use the module truck as the means to correct incorrect staging.

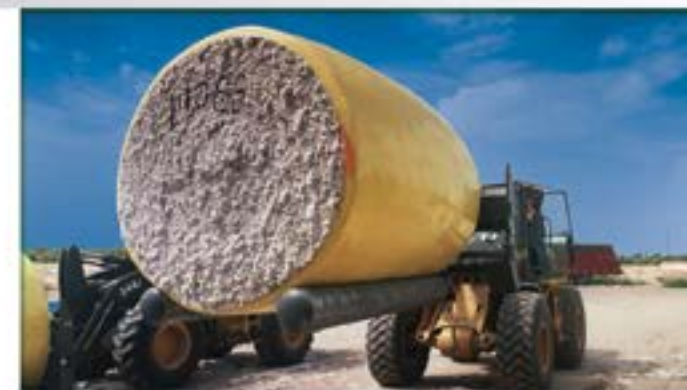
- 1) Cutting of the wrap must be opposite of the inner tail to eliminate the potential of cutting through the tail. An RFID is placed at the inner tail for locating.

- 2) Cutting of the wrap must be one cut along the entire length of the module.
- 3) Cutting of the wrap must result in a clean cut without leaving shards of plastic at the cut edge.

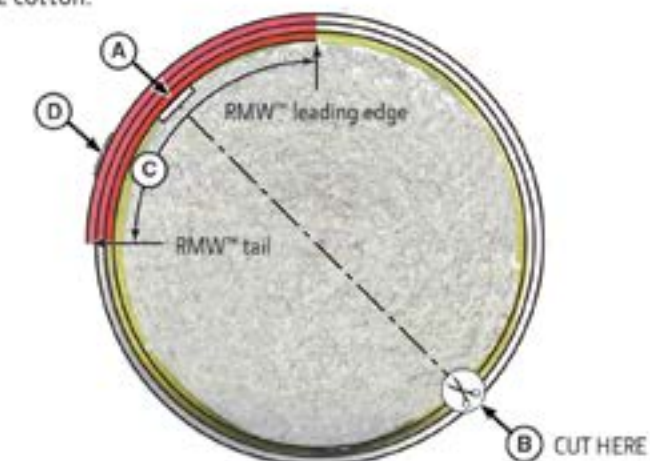
A RFID Tag
B Safe Cutting Zone

C RMW tail and leading-edge overlap (NO CUT ZONE)
D White metallic label

1. An average size module is between 228 cm (90 in) and 238 cm (94 in).
 2. An RFID tag (A) is located near the inner wrap end (usually it is not seen).
 3. The Safe Cutting Zone (B) is 180 degrees from the RFID tag location.
- NOTE:** The red zone (C) is a "No Cut Zone", as cutting in this area may cause small pieces of wrap to enter into the cotton.
4. If your RMW™ removal machine does not have an RFID reader – the Safe Cutting Zone (B) should be 180 degrees from the white metallic label with barcode and serial number (D) located 39 cm (15.5 in) above the RMW™ tail (visually seen).

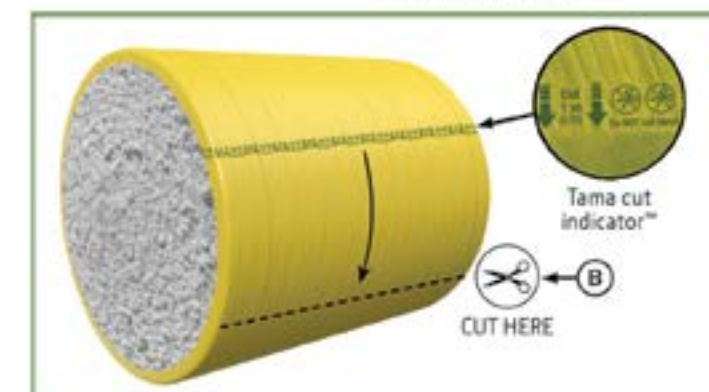
The Safe Cutting Zone is 1 meter (about 3 ft) from the Tama cut indicator™, with the direction of the arrows which appear on the Tama cut indicator™.
